In Vivo Observation of Cavitation and Embolism Repair Using Magnetic Resonance Imaging^{1[w]}

N. Michele Holbrook*, Eric T. Ahrens, Michael J. Burns², and Maciej A. Zwieniecki

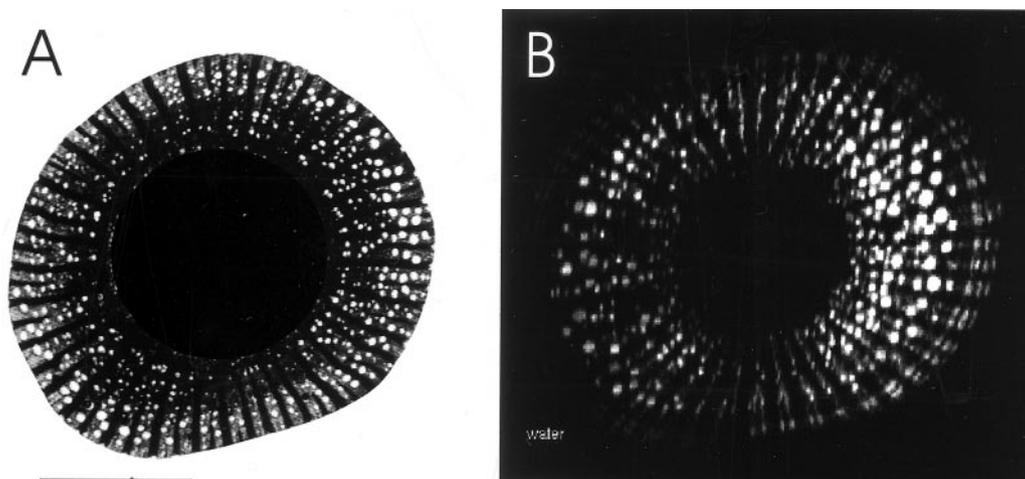
Figure 1. Cross section of grape stem using light microscope (A) or MRI (B). Scale bar in A = 2 mm. Note that the bark can be seen in the MRI image, but only the wood is present in the anatomical cross section (A).

As expected, regions of high water density in the M_r images corresponded with xylem vessels (Fig. 1). At the start of the experiment, leaf water potential was -1.25 MPa and the M_r image contained several regions with a low density of vessels, indicating that some cavitation had already occurred (Fig. 2). Over the next 24 h, approximately 10 additional vessels cavitated (Fig. 2). During this period, leaf water potentials fell to -2.1 MPa. There was no obvious spatial pattern to which vessels cavitated; on one side of the stem the cavitated vessels were somewhat clumped, whereas on the other side they were evenly dispersed.

The plant was continuously illuminated during the first 31 h of the experiment. At 24 h into the experiment the plant was rewatered (approximately 3 L of water added to the pot). After 9 more h the lights were turned off and the imaging continued for an additional 12 h. Leaf water potentials were measured using a pressure chamber. To avoid substantial reductions in leaf area and thus changes in plant water balance during the MRI measurements, the water potentials of only six leaves were measured. After the MRI session was completed, the stem was sectioned in the plane where the MRI images were taken.

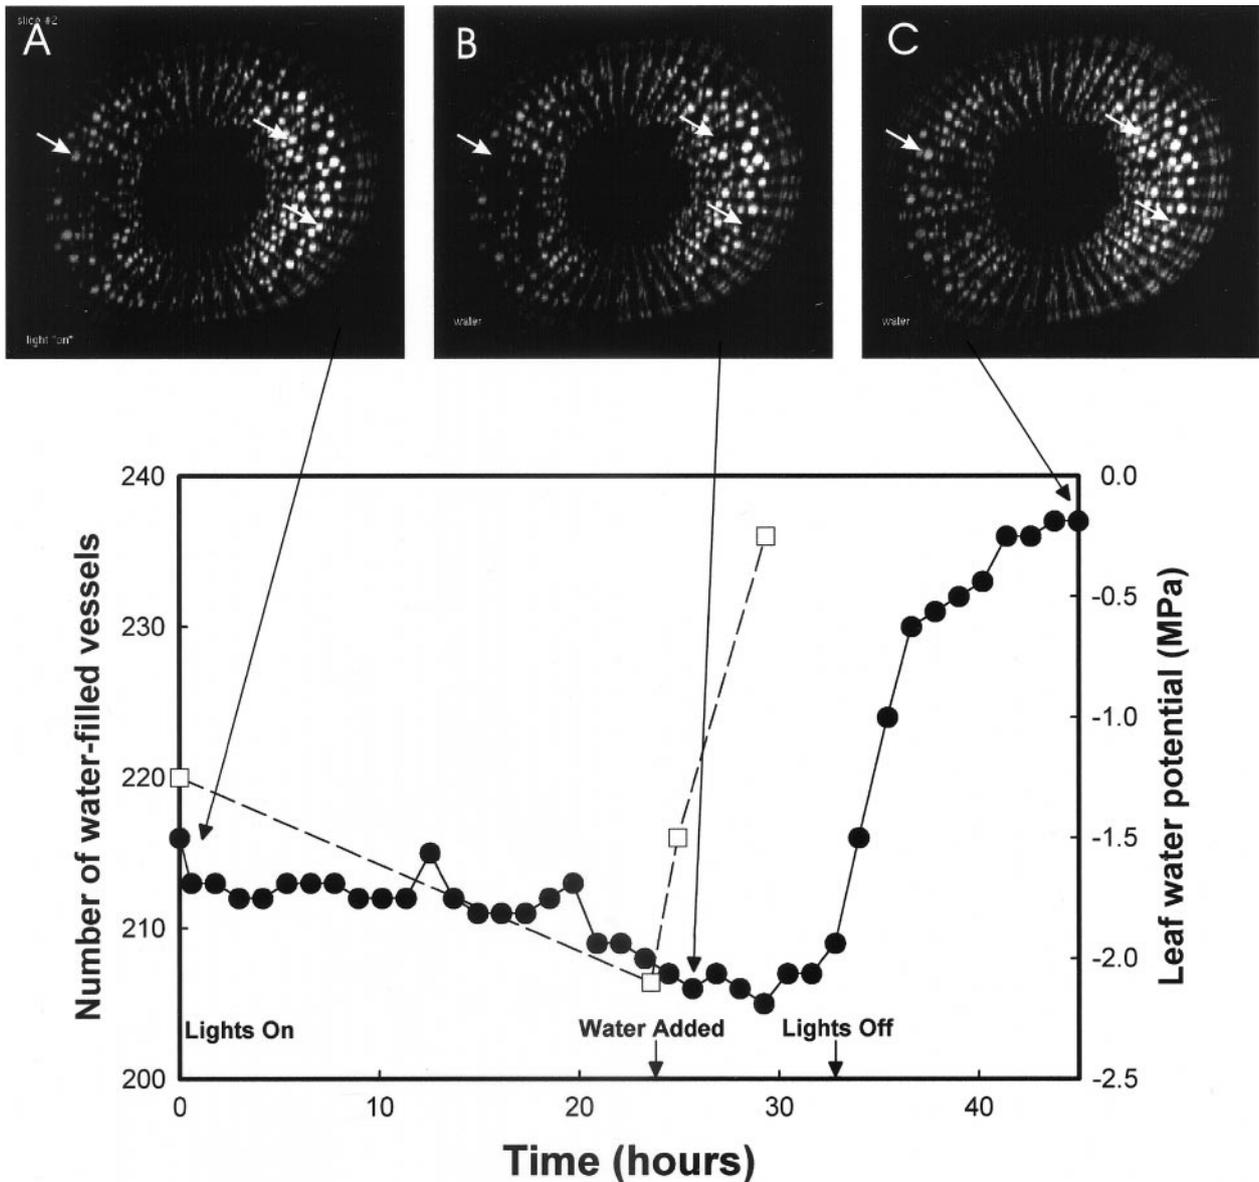
Figure 2. Time course of total number of vessels visible in the MRI images and leaf water potential as a function of time. A through C show representative MRI images, with white arrows marking vessels that were initially water filled (A), then gas-filled and hence not visible (B), and finally refilled with water (C). A QuickTime movie of all 39 images can be viewed at www.plantphysiol.org. Movie can also be viewed at <http://www.michaelburns.net/MRIMovie.html>

After the plant was rewatered, leaf water potentials increased rapidly to -0.25 MPa. During the period in which the lights remained on there was no change in the number of visible vessels in the MRI image. Once the lights were turned off, the number of water-filled vessels increased markedly (Fig. 2). After the first hour in the dark, the number of water-filled vessels was approximately equal to the start of the experiment. The number of water-filled vessels continued to increase over the next 12 h, although the rate of increase slowed with time. During this period there was no evidence of root exudation from a short side branch at the base that had been freshly cut. At the end of the experiment the plant was severed at the base and there were no visible signs of root exudation.

The time-dependent populations of filled and embolized vessels were quantified from time lapse data through a fixed image plane. The number of water-filled vessels in each MRI slice was counted by comparing each image to the last frame (frame 39) of that slice's sequence. The final

image was printed on a transparency and all distinct (i.e. water-filled) vessels were counted and circled. The other images (1–38) were then printed on paper and overlain, one at a time, on a back-lit reference image (frame 39). The number of missing vessels was counted for each of the frames and subtracted from the total number of vessels in frame 39.
